Inspection Report

Property Address:
2170 Harvey Ave.
Kelowna BC

C4U Inspections

Date: 2/23/2010	Time: 07:12 AM	Report ID:
Property: 2170 Harvey Ave. Kelowna BC	Customer: John Doe	Real Estate Professional: Ken Unger Prudential

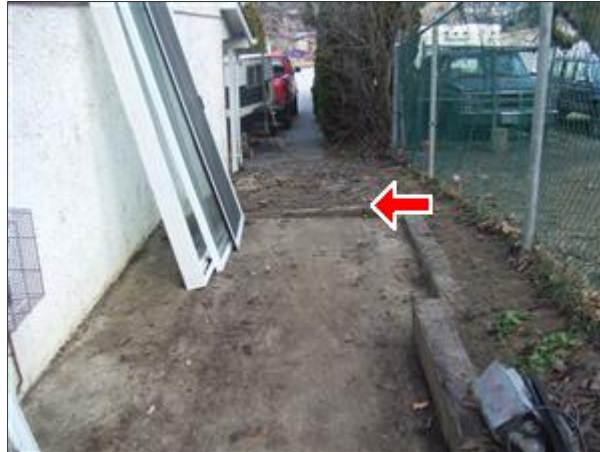
1.0 Picture 1

- (1) Sloped land at rear of home has vegetation, erosion protection & mature trees.
- (2) Wood in contact with earth subject to rot/insects. Recommend removal.

(3) Raise landscaping/earth where low including at left side (facing front) & slope away from building 6 feet using impervious/clay fill to direct water away from building to low areas to reduce seepage & foundation damage.

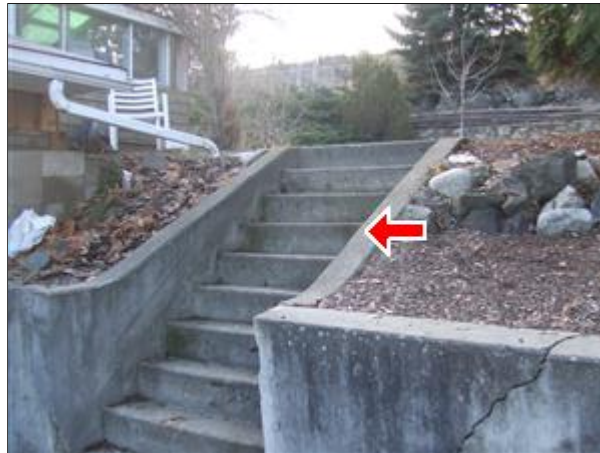
1.1 Picture 1

- (1) Slopes to building.
- (2) Spalled
- (3) Micro cracking typical for slabs this age. Patch if cracks open.
- (4) Add hand rails at rear of home step, to avoid a hazard.

- (5) Some hand rails loose- re-fasten.

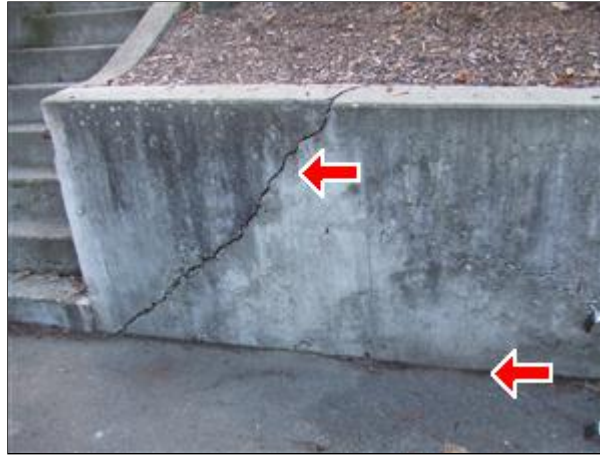
1.3 Picture 1

- (1) Wall leans: is displaced.
- (2) Vertical cracking in concrete. No significant movement/displacement.

(3) Add weep holes to reduce hydrostatic pressure behind walls.

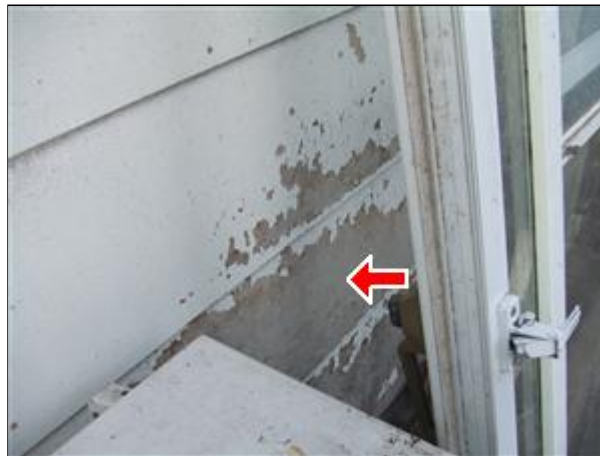
1.4 Picture 1

(1) Foundation & lower walls concealed by steps, storage, patio, vegetation - cannot view all.

(2) Paint failing on siding. Needs prep and paint at exterior.

(3) Bare wood needs primer and paint at exterior.

(5) Caulk/seal chips/cracks in stucco.

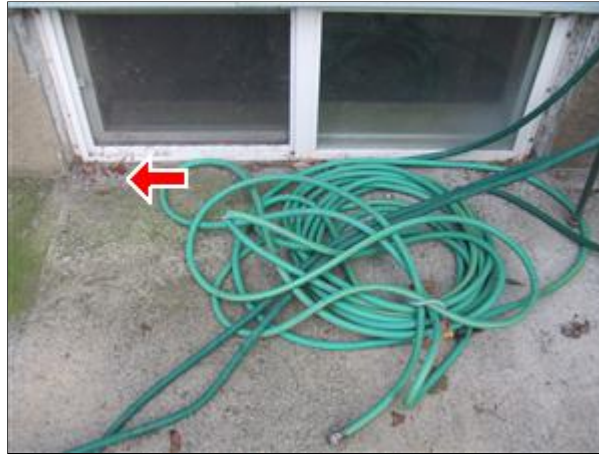
1.5 Picture 1

No window well can add curb to prevent moisture from entering

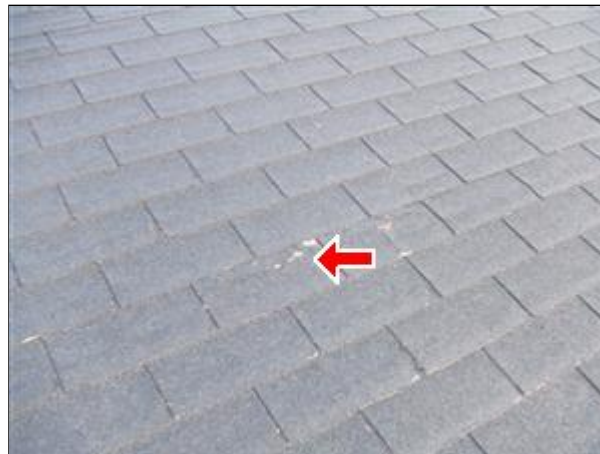
2.0 Picture 1

- (1) Moss - add zinc strips to remove
- (2) Excessive granules coming off of shingles. This is usually from inadequate attic ventilation or possibly a manufacturer defect. The cause of moisture needs to be found and corrected.
- (3) Roof is near/past end of useful life. Replace in near future to avoid leaks. Replace badly damaged areas & repair/monitor other sections to avoid leaks & extend life a few years.

- (4) Be advised: roofing contractors tend to recommend replacement over maintenance when solicited.
- (5) The roof covering has hairline cracks in various areas. This is possibly from a manufacturer defect. The roof could leak. I recommend repair or replace.

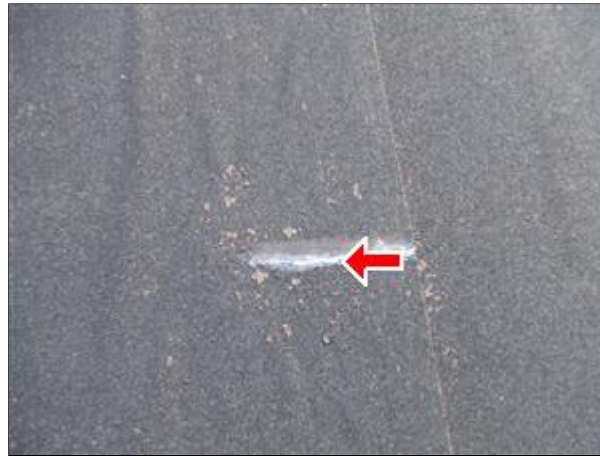
2.0 Picture 2

(6) Patched

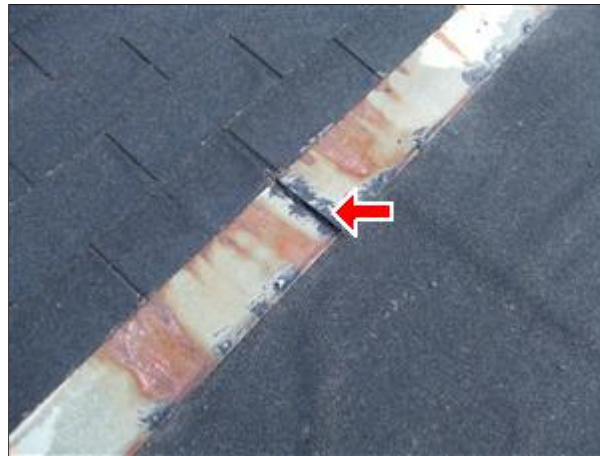
2.1 Picture 1

(1) Some corrosion and loose flashings repair/replace

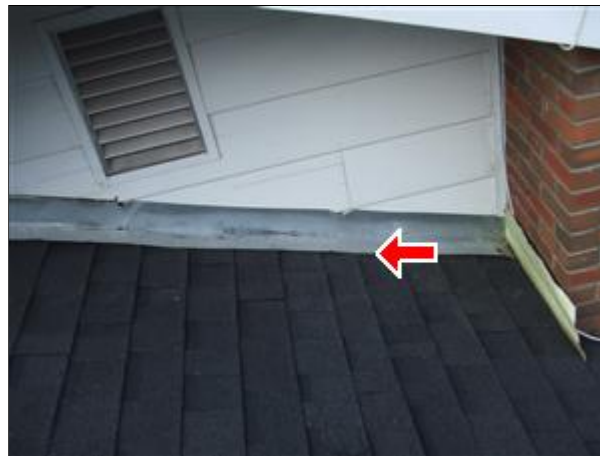
2.1 Picture 2

(2) Roof to wall flashings installed improperly. Repair flashings or caulk to avoid leaks.

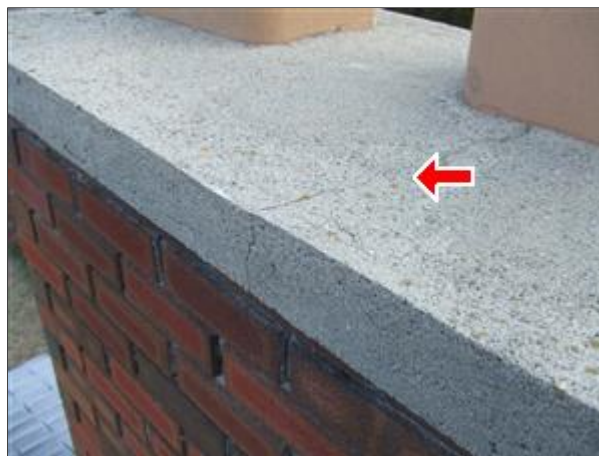
2.2 Picture 1

(1) Rust/corrosion at metal chimney/flashing paint with rust proof paint to extend life.

(2) Caulk cracks & joints at cap to avoid leaks.

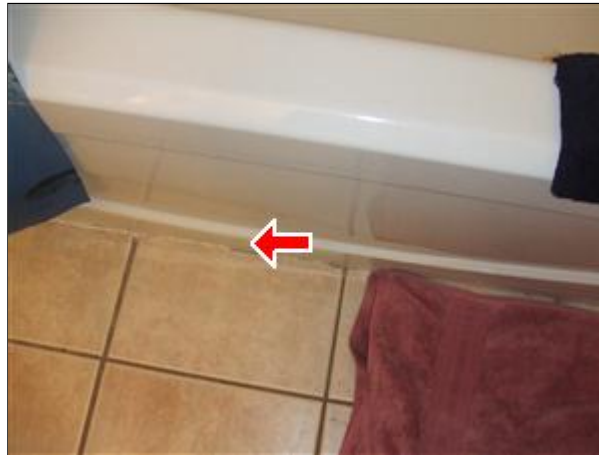
7.2 Picture 1

(1) I recommend silicone caulk along floor and tub at hall bath.

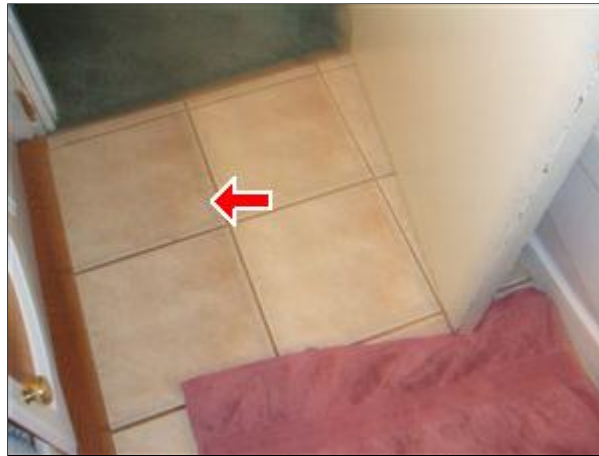
7.2 Picture 2

(2) Some cracked tiles.

(3) Some grout lines cracked/loose - re-grout/re-cement/seal to protect structure behind.

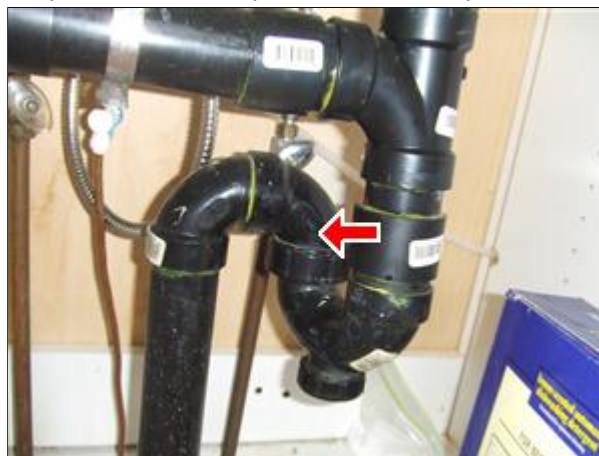
8.0 Picture 1

The plumbing waste line is a S trap and needs upgrade to a P trap with an auto-vent under the kitchen sink. This is not considered up to today's standard. A qualified licensed plumber should repair or correct as needed.

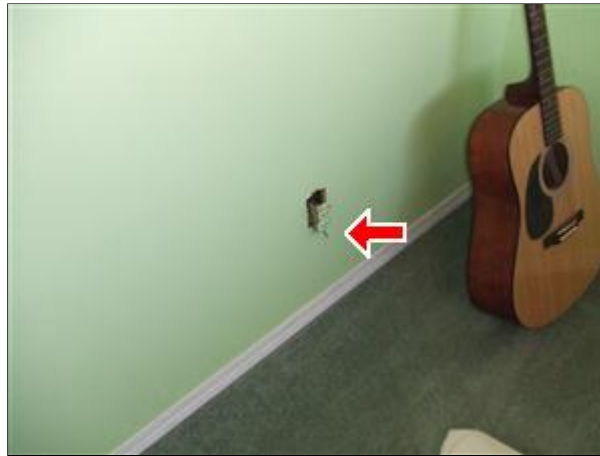
9.3 Picture 1

(3) Receptacle/switch/junction box covers missing broken. Replacement recommended to reduce shock hazard.

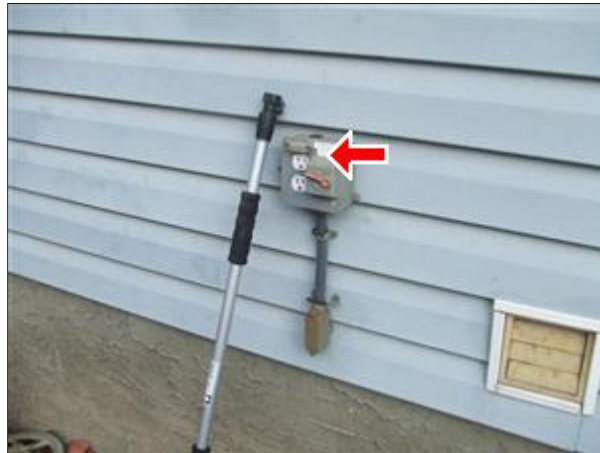
9.5 Picture 1

The GFCI outlet at the exterior is a non-grounded outlet which is currently acceptable, however, it should be labeled a non-grounded GFCI and it is not as safe as a grounded GFCI (for your information).

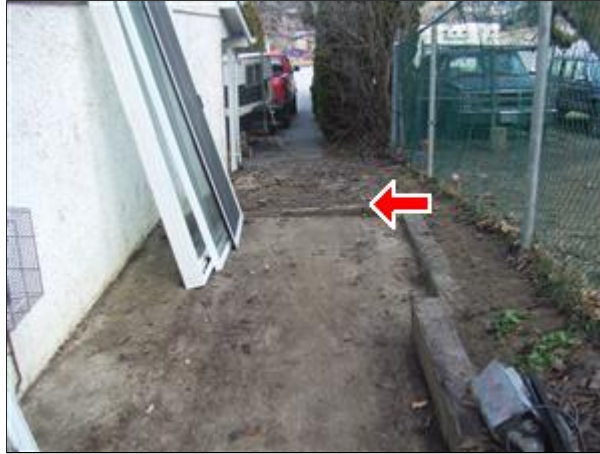
1.0 Picture 1

- (1) Sloped land at rear of home has vegetation, erosion protection & mature trees.
- (2) Wood in contact with earth subject to rot/insects. Recommend removal.
- (3) Raise landscaping/earth where low including at left side (facing front) & slope away from building 6 feet using impervious/clay fill to direct water away from building to low areas to reduce seepage & foundation damage.

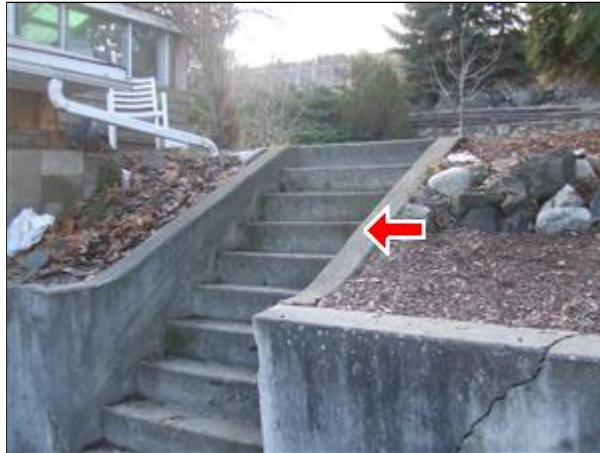
1.1 Picture 1

- (1) Slopes to building.
- (2) Spalled
- (3) Micro cracking typical for slabs this age. Patch if cracks open.
- (4) Add hand rails at rear of home step, to avoid a hazard.

- (5) Some hand rails loose- re-fasten.

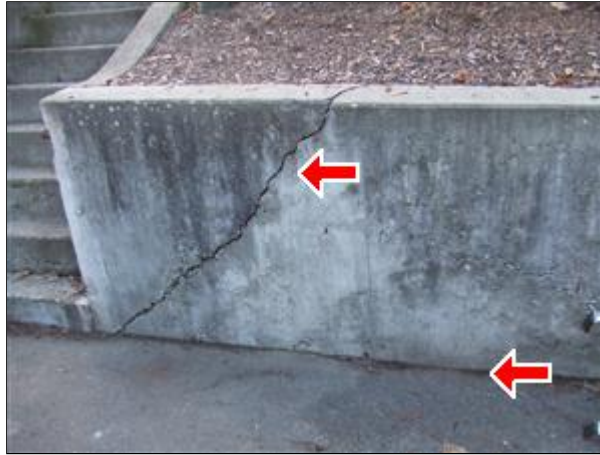
1.3 Picture 1

- (1) Wall leans: is displaced.
- (2) Vertical cracking in concrete. No significant movement/displacement.
- (3) Add weep holes to reduce hydrostatic pressure behind walls.

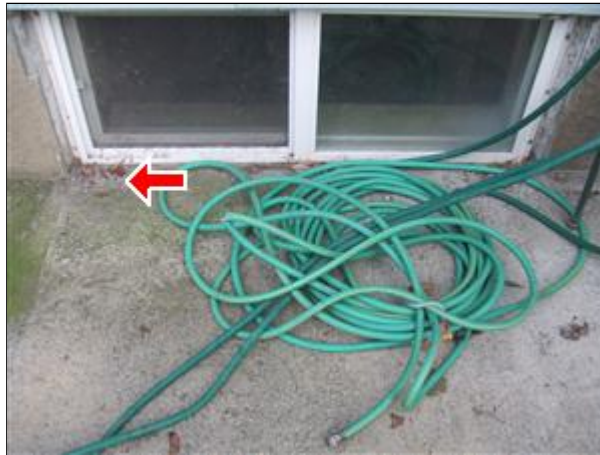
1.5 Picture 1

No window well can add curb to prevent moisture from entering

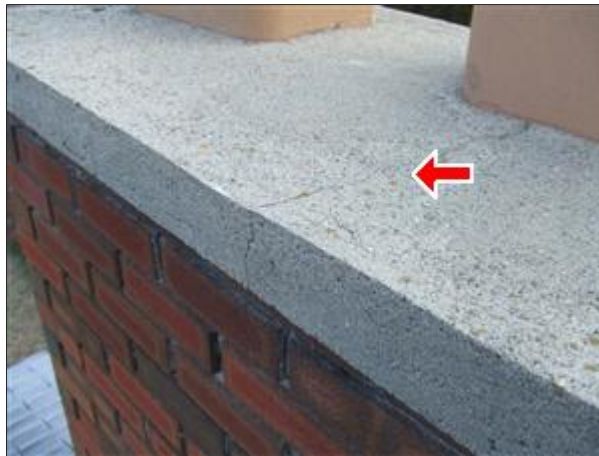
2.2 Picture 1

- (1) Rust/corrosion at metal chimney/flashing paint with rust proof paint to extend life.
- (2) Caulk cracks & joints at cap to avoid leaks.

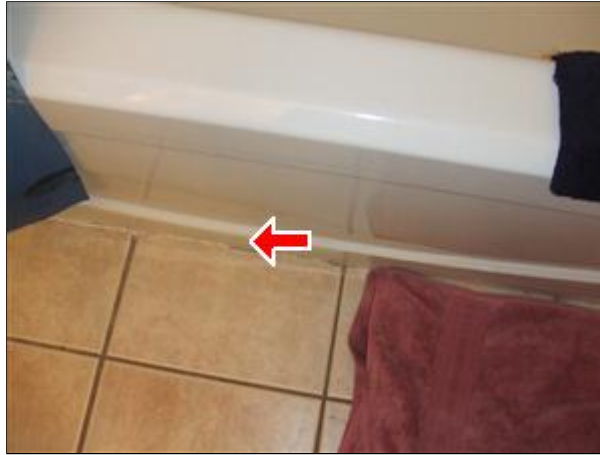
7.2 Picture 1

(1) I recommend silicone caulk along floor and tub at hall bath.

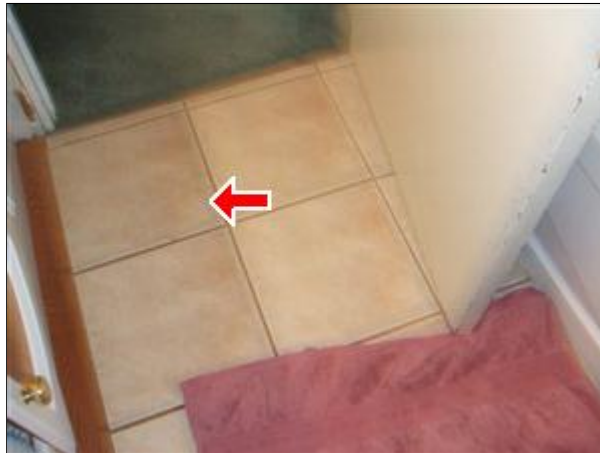
7.2 Picture 2

(2) Some cracked tiles.

(3) Some grout lines cracked/loose - re-grout/re-cement/seal to protect structure behind.

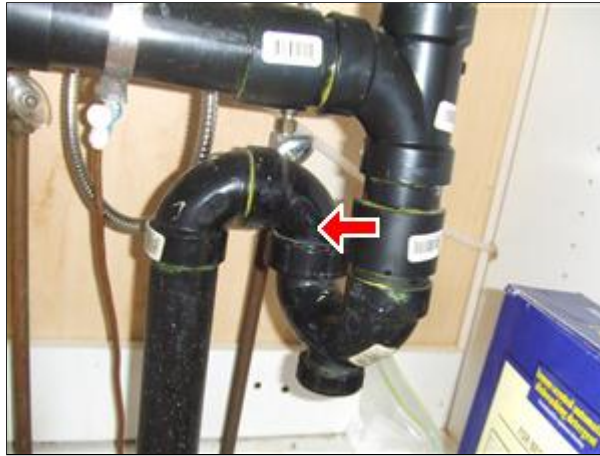
8.0 Picture 1

The plumbing waste line is a S trap and needs upgrade to a P trap with an auto-vent under the kitchen sink. This is not considered up to today's standard. A qualified licensed plumber should repair or correct as needed.

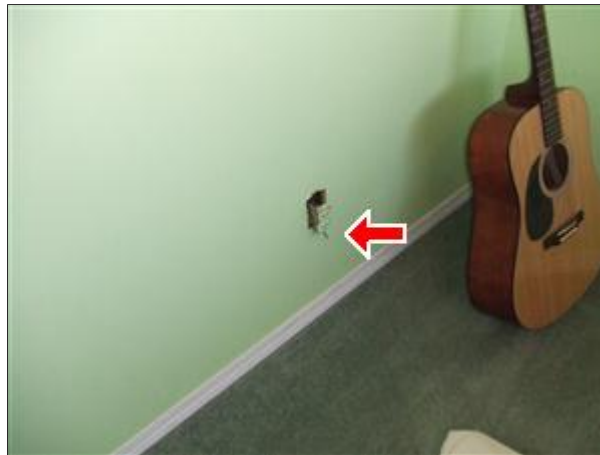
9.3 Picture 1

(3) Receptacle/switch/junction box covers missing broken. Replacement recommended to reduce shock hazard.
